Sdr. Vissing WWTP

Effluent polishing at a small municipal waste water treatment plant

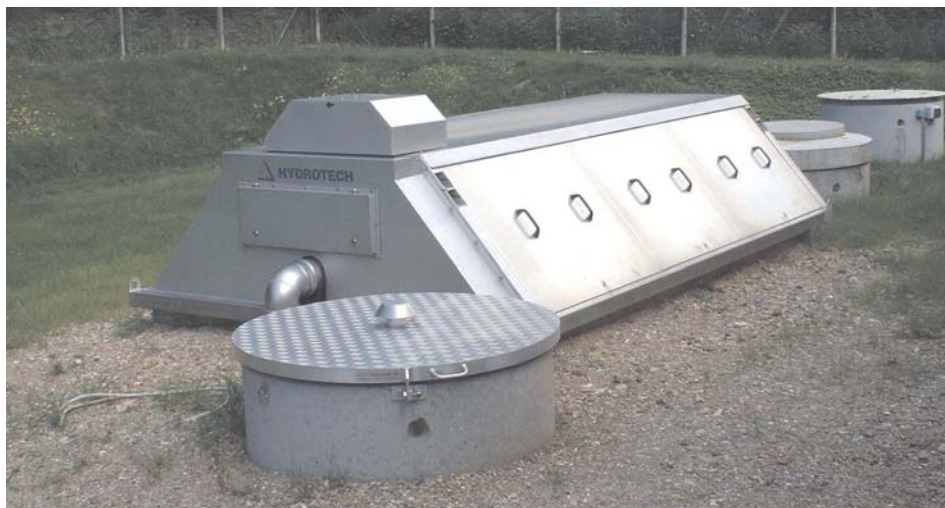
Picture: Hydrotech Drumfilter HDF2007-1L, 18 µm filter opening, maximum flow 50 l/s.

A new version of the well known Hydrotech drumfilter was installed, model HDF2007-1L. The filter was delivered as a complete unit in a tank. The drive has been changed to a belt drive, replacing front bearings as well. A patented moving spray bar ensures even better cleaning of the cloth. In case of overloading of the filter, an internal by-pass leads the water around the filter, protecting rinse water nozzles from becoming blocked by suspended material.

Rinse water consumption has been reduced from 2,1 l/s to 1,8 l/s (at continuous operation) and energy consumption has been reduced from 3,0 kW to 2,2 kW as installed effect in rinse water pumps.

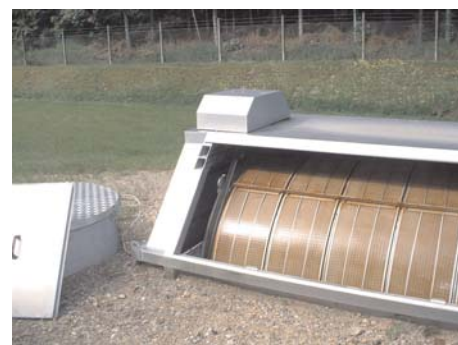
Picture: Phosphates are precipitated using iron-chloride and it can be seen that the filter cloth is becoming red in colour.

The filter has been in operation since April, 2000 and until now a standard high pressure cleaning of the cloth has been sufficient.

If precipitated iron leads to blocking of the filter, the cloth can easily be cleaned by washing with dilute hydrochloric acid without using any detergents.
